DE LOREAN MOTOR COMPANY

# SERVICE BULLETIN

NUMBER SC-01-11/81

SUBJECT: SAFETY CAMPAIGN NO. RA-0001 (RECALL)  
BALL JOINTS - STABILIZER BAR MOUNTINGS - V.I.N. 560 - 6650\*

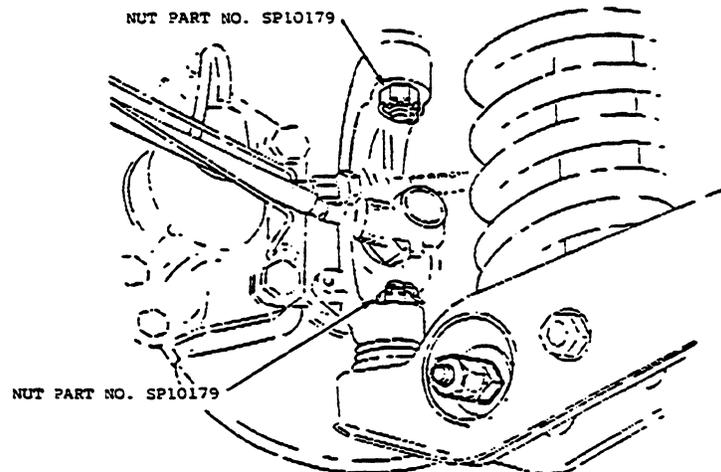
FIGURE 1

REPAIR PROCEDURE - BALL JOINTS

4. Remove left-hand existing ball joint upper and lower retaining nuts and discard.

5. Install castellated nuts Part No. SP 10179 to upper and lower ball joint. Torque to 50NM (37 ft/lbs.)
6. Using slots in nuts as a guide, drill 3.3mm hole through the ball joint's threaded studs.
7. Remove metal shavings.
8. Insert split pins Part No. SP 10340 3mm x 26mm. Bend the pin ends - lower portion over nut and top portion over ball joint thread.
9. Repeat procedure for right-hand side upper and lower ball joints.

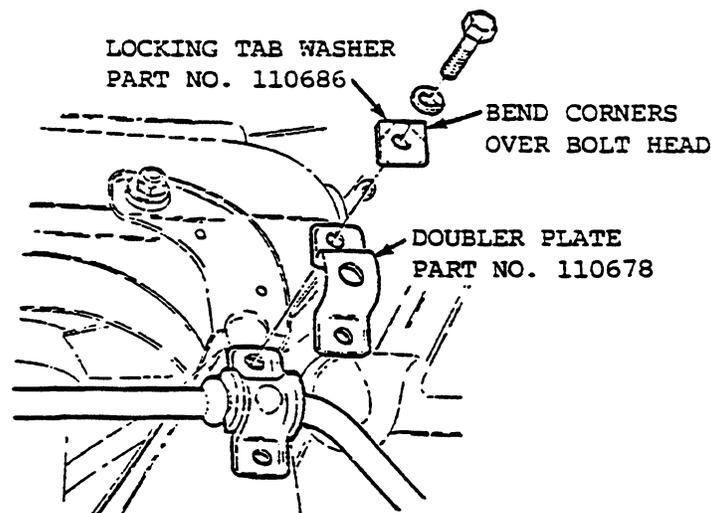
FIGURE 2

REPAIR PROCEDURE - STABILIZER BAR MOUNTING BRACKET

3. Install reinforcement bracket Part No. 110678 over the existing bracket.
4. Install lock tab, lock washer and bolt as shown in Figure 2 (using existing lock washer and bolts).
5. Torque bolts to 35NM (26 ft/lbs).
6. Bend locking tabs as per Figure 2.

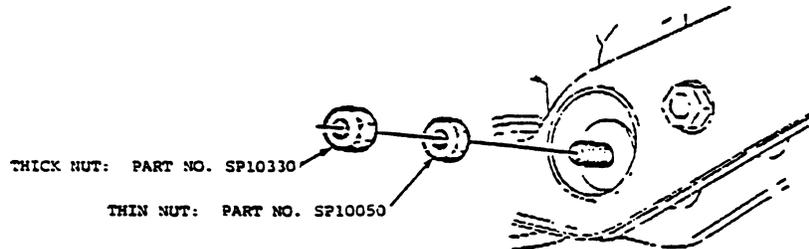
FIGURE 3

STABILIZER BAR TO LOWER LINK MOUNTINGS

1. Remove existing nylock nut and discard.
2. Clean stabilizer bar threads.
3. Coat stabilizer bar threads with Stud-N-Bearing Mount Loctite or Stud-N-Bearing Mount Permatex. Install thin nut Part No. SP 10050 and torque to 60NM (44 ft/lbs).
4. Recoat remainder of the thread with Stud-N-Bearing Mount Loctite or Stud-N-Bearing Mount Permatex and install thick nut Part No. SP 10330 and torque to 90NM (68 ft/lbs). When performing Step 4, ensure that the thin nut doesn't rotate.
5. With red paint, color code all areas of rework: top and bottom ball joints, right and left-hand front stabilizer bar mountings, rear stabilizer bar mountings.
6. Lower hoist to waist level, mount road wheels and torque to specification 80NM (59 ft/lbs).
